# NATIONAL TRANSPORTATION SAFETY BOARD

## RAILROAD ACCIDENT REPORT

FIRE ONBOARD AMTRAK PASSENGER TRAIN  
TRAIN NO. 11, COAST STARLIGHT  
GIBSON, CALIFORNIA  
JUNE 23, 1982

NTSB / RAR-83 / 03

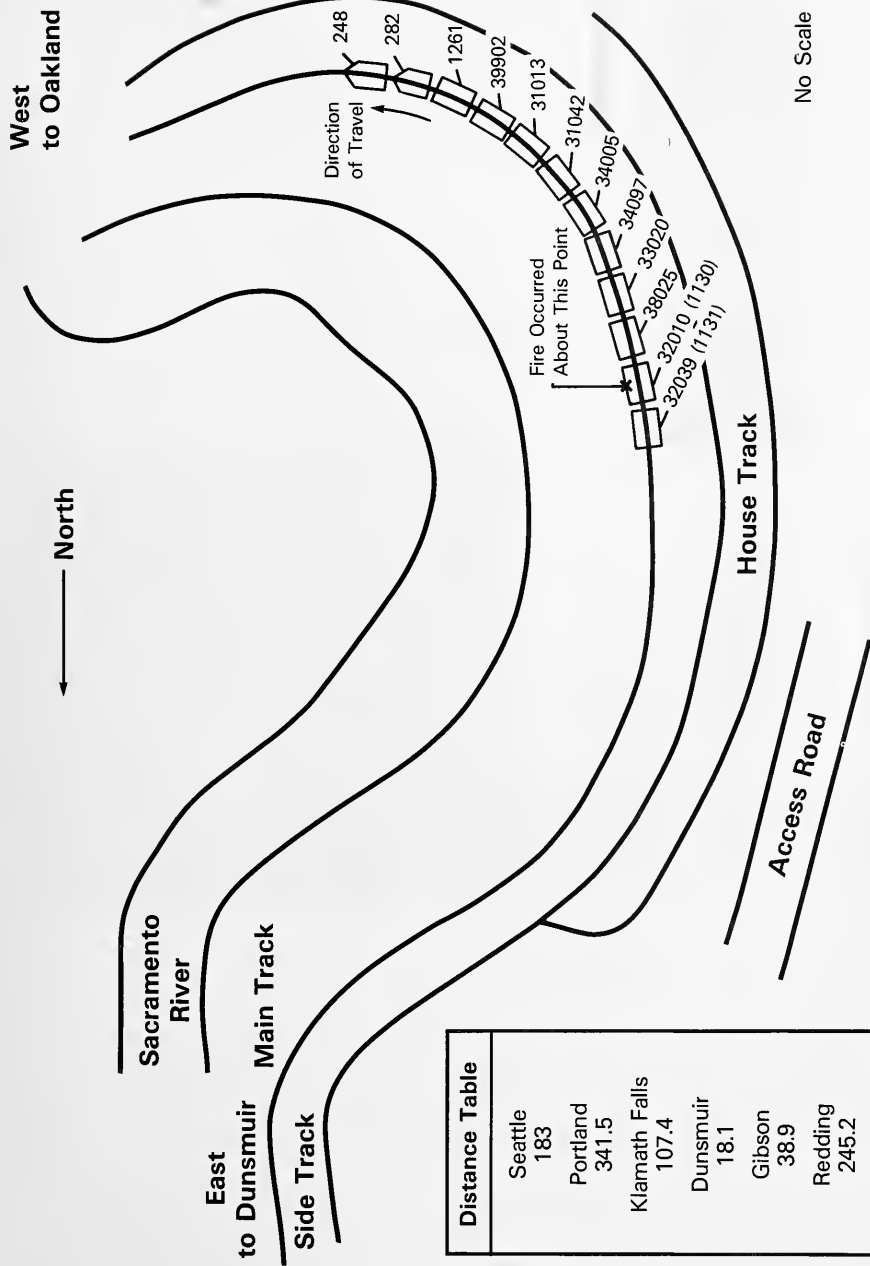
Figure 3.--Plan view of accident site.

The engineer said that he and the fireman looked northward at the train, which was standing in a left-hand curve in the direction of travel. (See figures 3 and 4.) They could see a yellowish light in the upper part of the 1130 car that was unlike the normal light reflected from a rail passenger car. When the engineer became aware of the magnitude of the fire, he radioed the dispatcher to send emergency fire assistance. Later, the conductor instructed him over the radio to make the moves required to separate the two rear cars in the train. The engineer said that he assigned the locomotive fireman the task of shutting off the electrical power to the train before the cars were uncoupled. The
